# **INFORMATION HANDOUT**

**For Contract No. 04-1SS364**

**In Healdsburg At 0.1 Mile South of Grant Avenue Undercrossing**

Subject: **Geotechnical Design Report (GDR)**

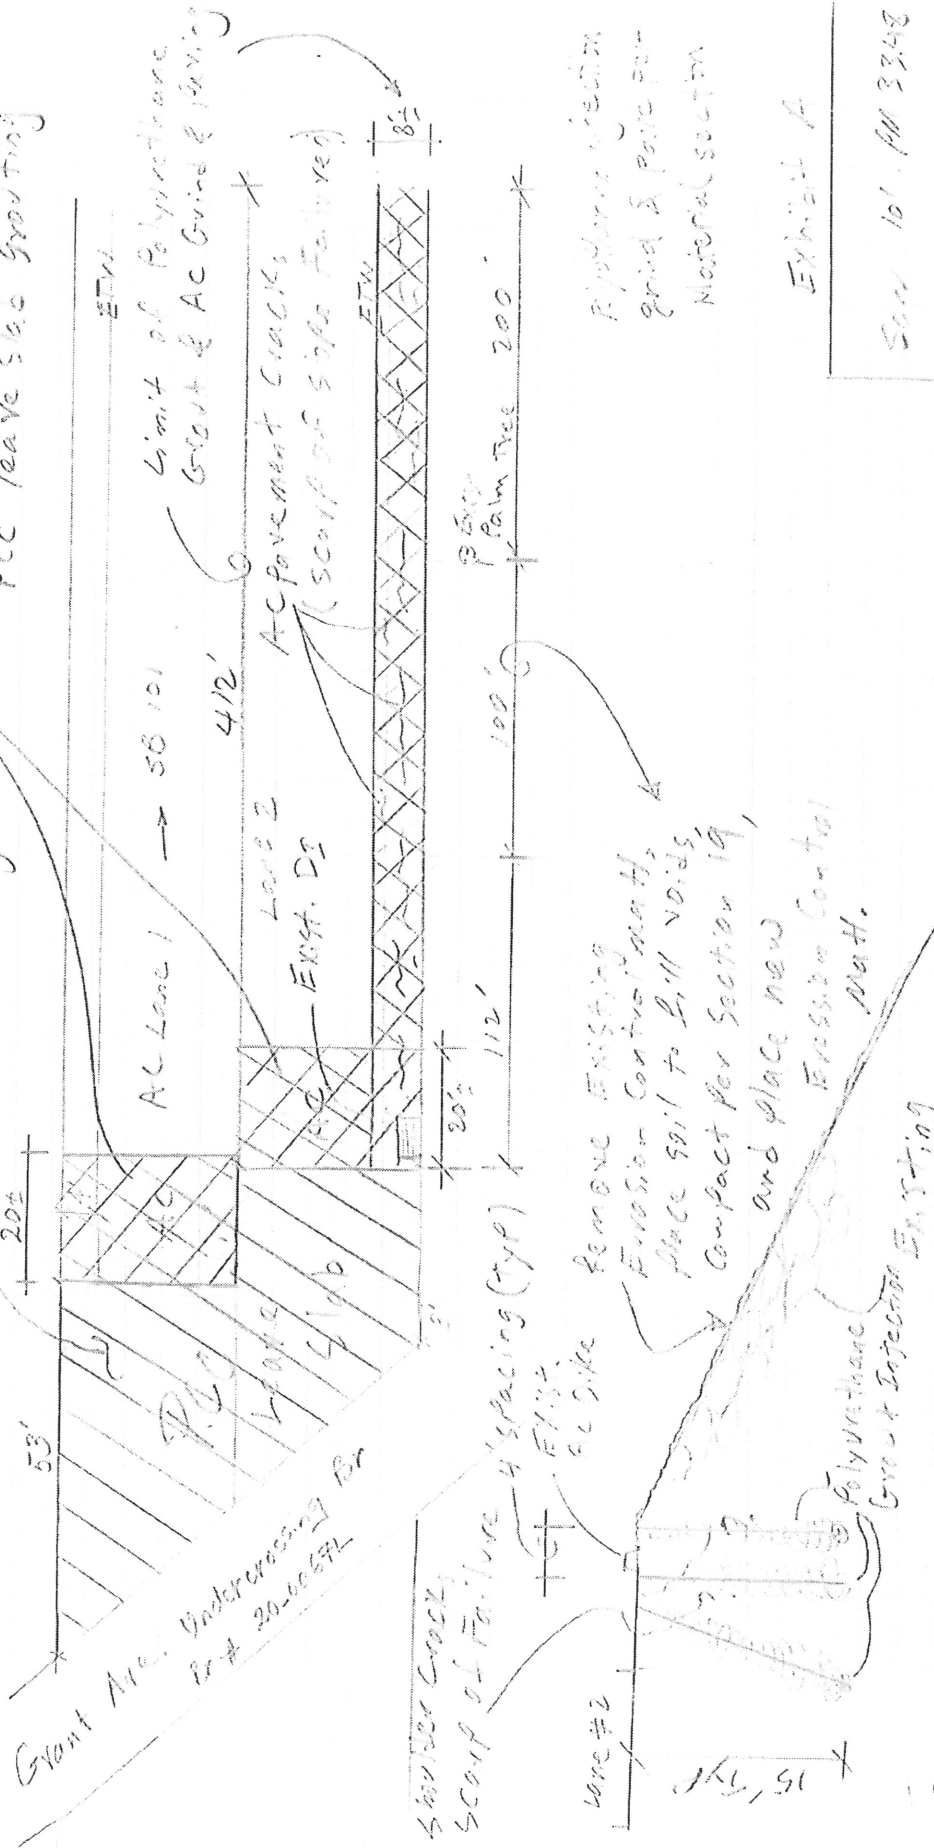
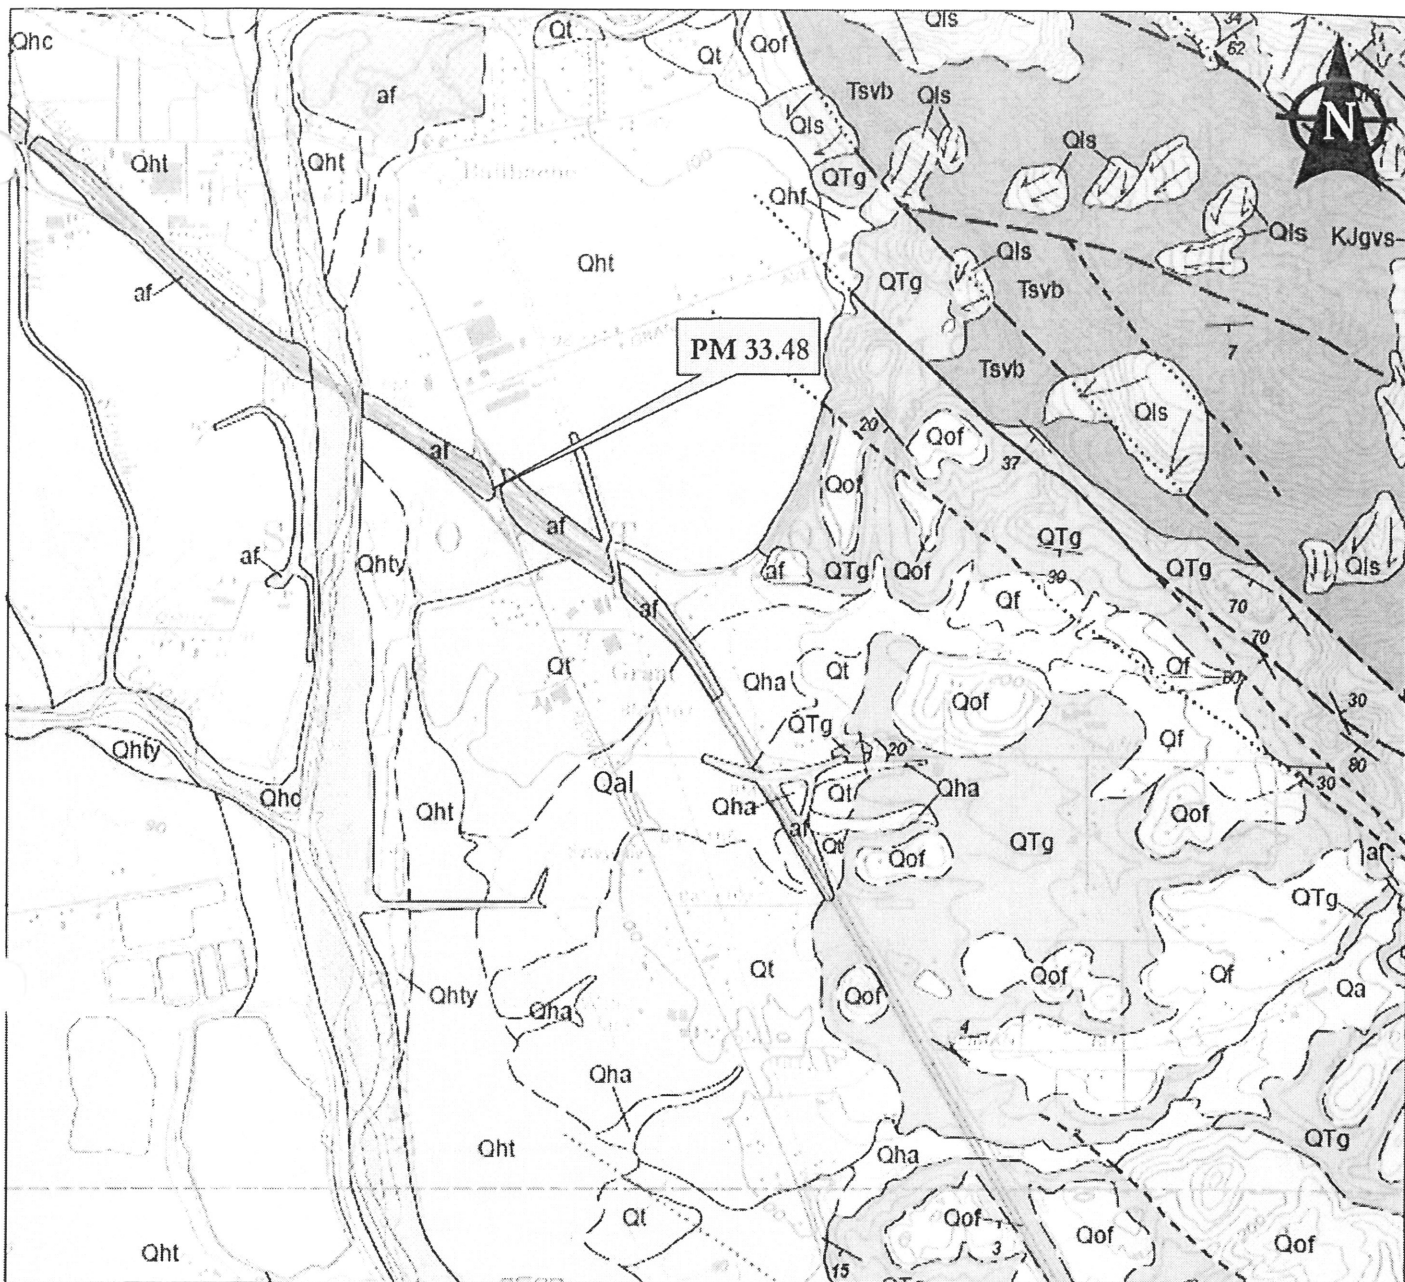
This memorandum presents our geotechnical recommendations for the above referenced project. The project site is located on Route 101, PM 33.48 at Grant Avenue Undercrossing (UC) in the City of Healdsburg in Sonoma County. The recommendations contained in this report are based on the results of our previous field investigation in 2012 and recent site visits (March 28, 2014). The recommendation addresses the **settlement of the existing PCC leave slab, slope erosion under the Grant Ave UC (Bridge No. 20-0067L), erosion on the outside shoulder embankment side slopes,** and unstable shoulder with significant amount of roadway pavement cracks (scarp of slope failures) for a length of about 412'. See attached Exhibit A for details.

During early 2012, rainstorms caused the settlement of the existing PCC leave slab, erosions of the embankment slope under the bridge abutment exposing one of the abutment piles, outside embankment shoulder erosion/failure, and shoulder AC pavement cracking (scarp of slope failures). Two reports, Project Initiation Report (PIR) dated March 3, 2012 and Addendum to PIR dated April 17, 2012 (copies attached, Attachment 1) were prepared by this office to initiate a project. Please refer to these reports for complete background of this project. Since then, per our recommendation stated in the PIR, Field Maintenance has repaired the eroded outside shoulder side slope by placing Rock Slope Protection (RSP) mixed with soil and erosion control netting in 2013. In addition, Maintenance paved the shoulder in this area for a length of about 100 ft. See attached Exhibit A for details. Since then, some of the mixed soils have been washed away through the erosion netting creating exposed voids between the rocks.

Polyurethane Injection  
 Light weight Grout  
 & PCC Lifting

AC Pavement to be  
 grouted @ the time of  
 PCC leave slab grouting

- Using lightweight polyutherane material grout injection, stabilize the foundation of the settled PCC leave slab to the depth of about 15' below the ground surface. Then lift the slab as required (about 2") to establish proper profile of the roadway. For the limits of grouting and details, see attached Exhibit A.

1. Using polyutherane material grout injection, stabilize the failing existing outside shoulder to the depth of 15' below ground surface for a length of 412 ft. See attached Exhibit A for details. The lightweight polyurethane material grout and the injection steel pipe piles will remain in the ground and will be penetrating into the failure planes to increase the shear strength of the

2. Grind the AC pavement, for the entire 412' affected area, place pavement enhancement fabric, and place new pavement. Consult Materials for their specific recommendations and details.
3. Reconstruct the existing AC Dike to prevent any sheet flow of the runoffs during storm events.
